**Flood Control Project Maintenance
Levee Inspections**
LMA District Cover Sheet
Spring 2009 Levee Inspection Results

Reclamation District No. 0001

Levee Inspection Report By Mile - Spring 2009

Waterway	Bank	Unit Miles	Inspection Start/End	Inspector
Unit No. 01 Old River	Right	1.20	05/13/2009 05/13/2009	Herman Phillips

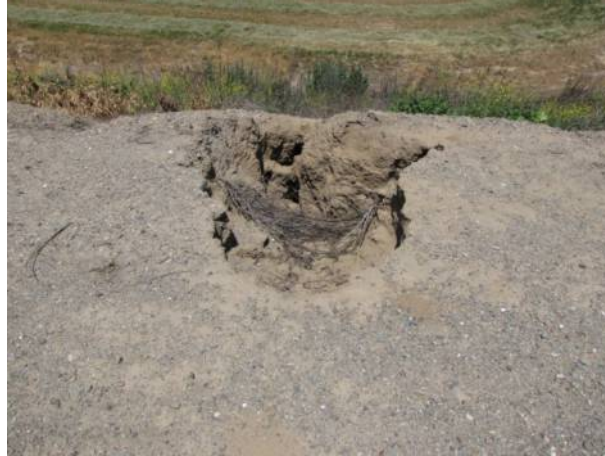
Levee Mile Report Line	2
Start Levee Mile	0.53
End Levee Mile	0.53
Location	Land Side
Category	Earthen Levee
Item	Erosion / Bank Caving

This was a rodent hole that rain run off has caused erosion on the land side shouder.

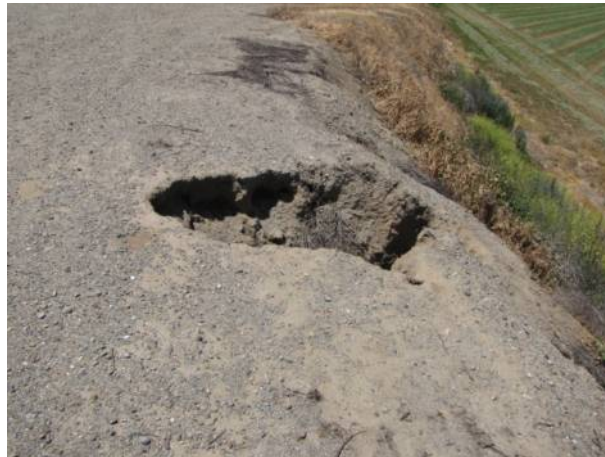
Levee Mile Report Line	2
Start Levee Mile	0.53
End Levee Mile	0.53
Location	Land Side
Category	Earthen Levee
Item	Erosion / Bank Caving

Same rodent hole erosion looking downstream landside shouder.
